MID-WALL WINDOW

OUTER WALL WINDOW

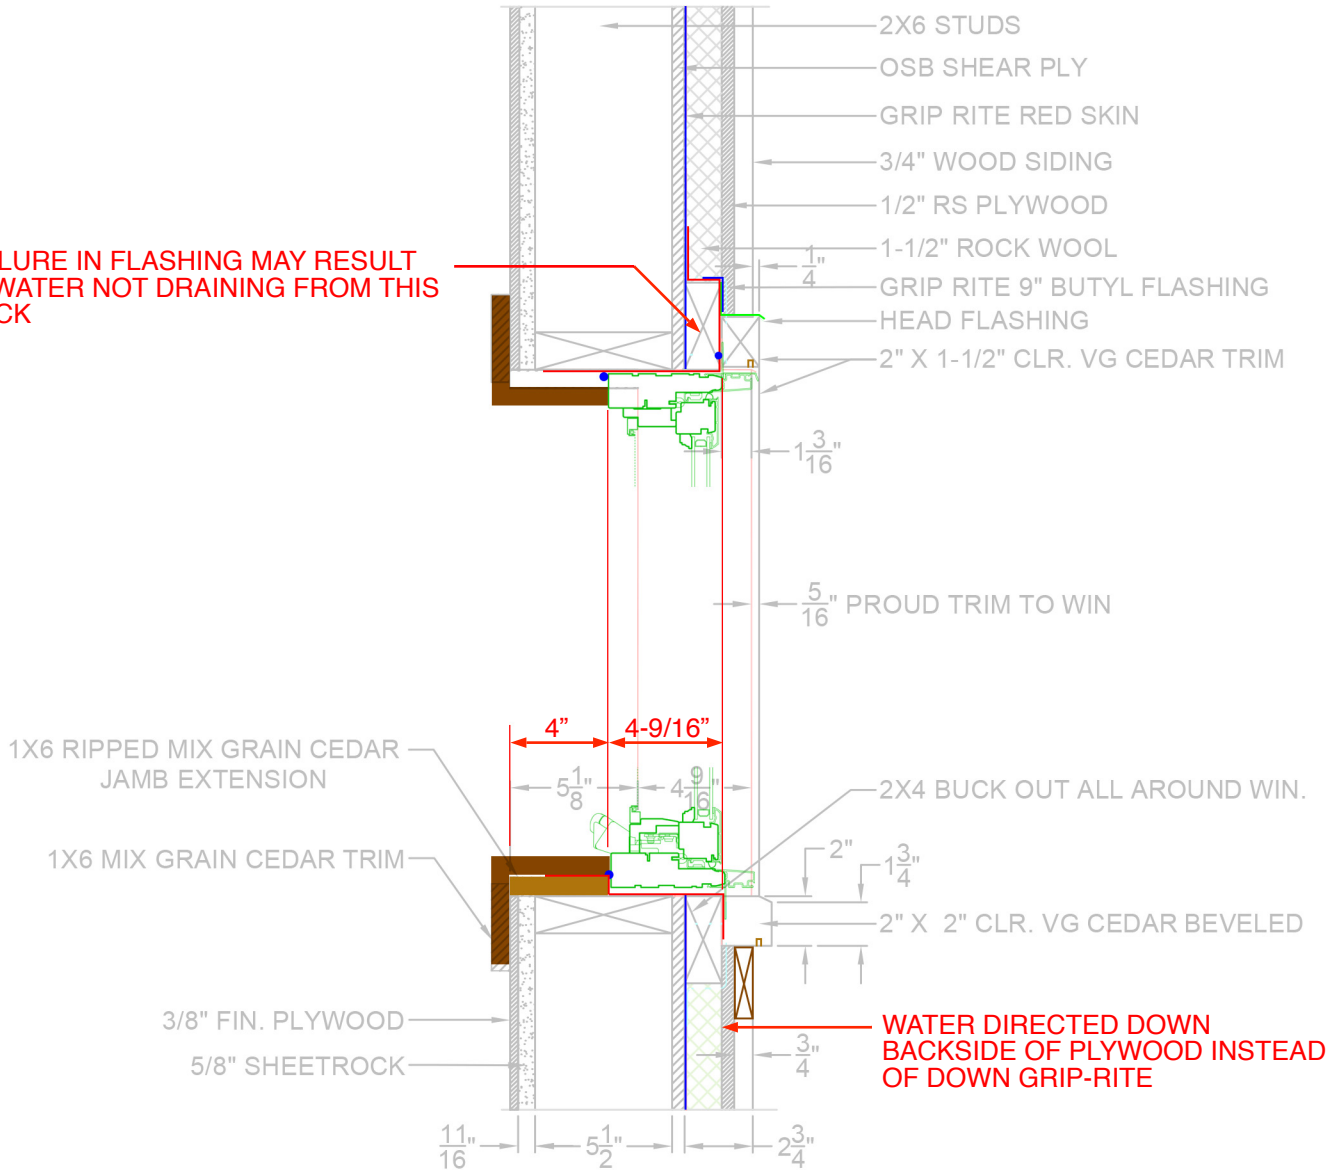
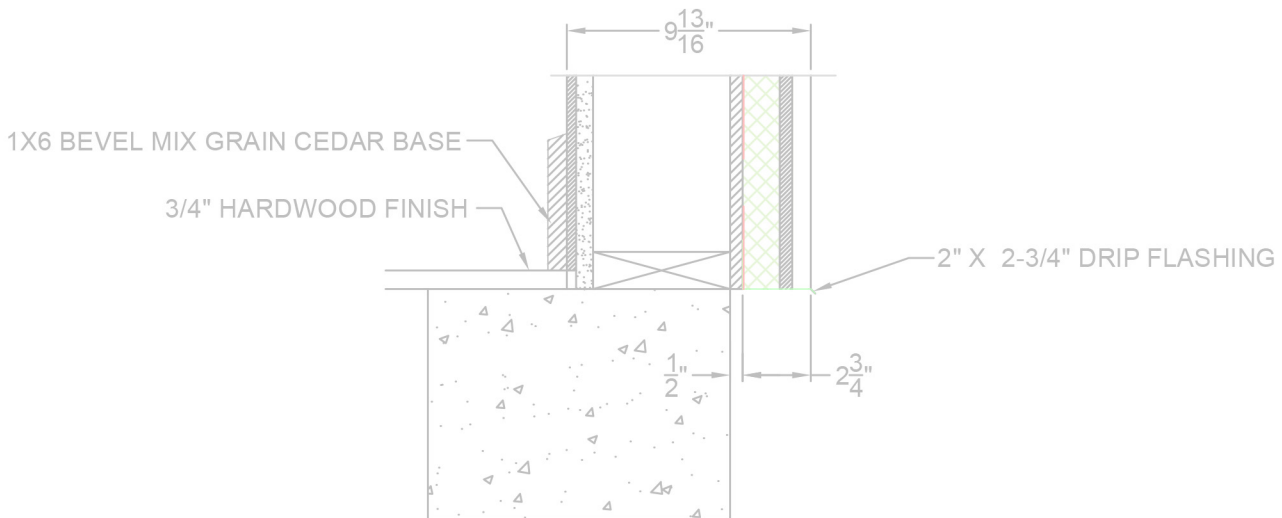
**SEE MID-WALL WINDOW
FOR DETAILING**
Differences noted below

**FAILURE IN FLASHING MAY RESULT
IN WATER NOT DRAINING FROM THIS
BUCK**
